**An Investigation into Bridge Usage by Bats
within the Sullane & Laney River Catchments, Co. Cork**

Mark Masterson, Daniel Buckley, Mary O'Brien and Conor Kelleher

Cork County Bat Group

March 2008

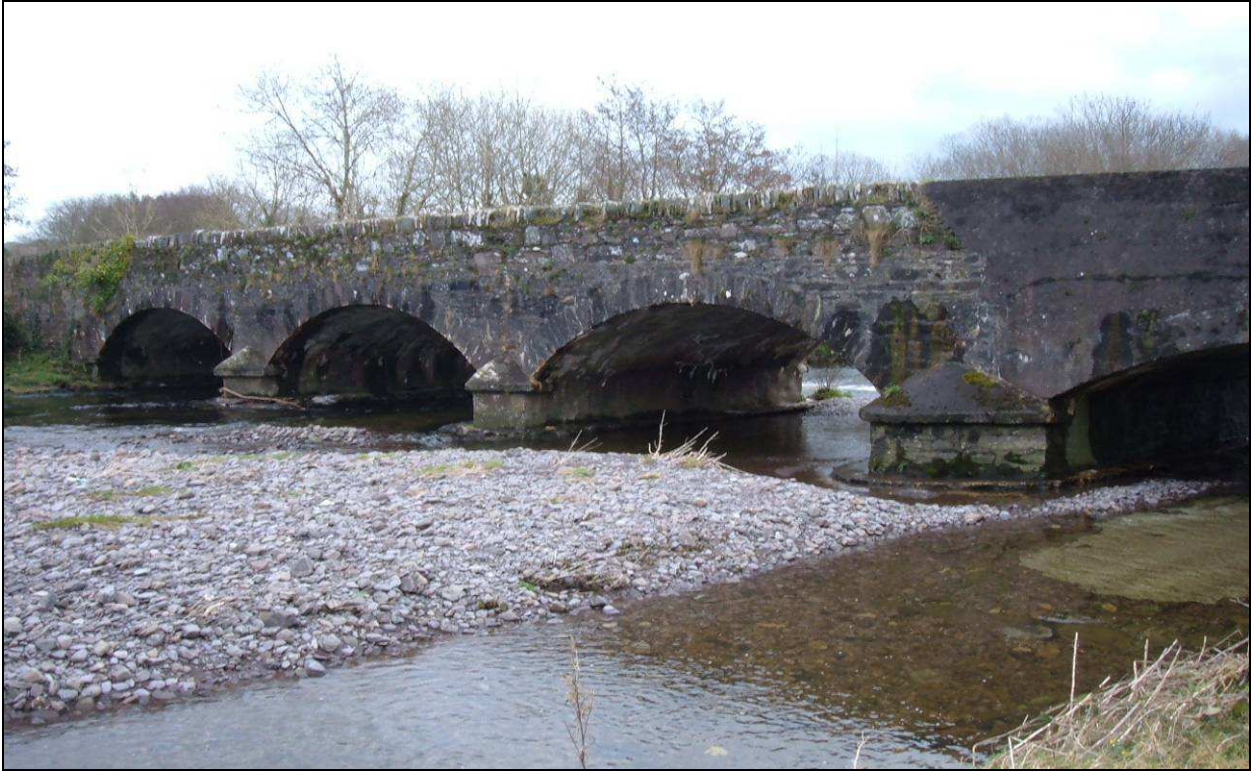
Plate 1: Bridge 111, Ballymakeera Bridge on the River Sullane

Masonry bridges (Plate 1) were designed for the horse and cart. Unfortunately, the increase in vehicular traffic has undermined many structures and, as a consequence, there is a need to strengthen these bridges. The conventional method is to 'pressure grout' the bridge by means of injection spraying of concrete which can entomb any animals within..

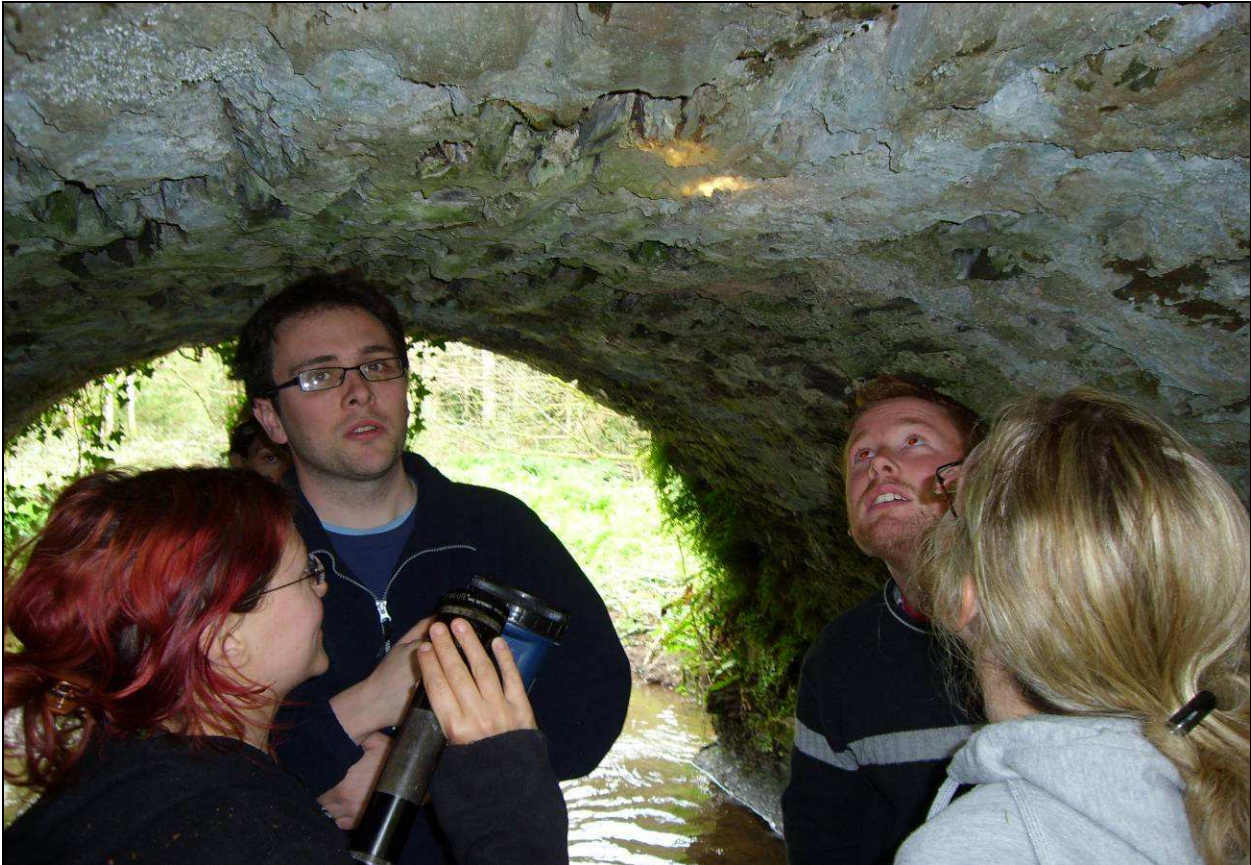
Plate 2: Volunteers inspecting bridge arch during training session

A key aim of the survey was to encourage the participation of volunteers, therefore, prior to undertaking the study, a public meeting was organised, in April 2007, during which a presentation on the survey aims, requirements, needs and methodology was given and this was followed-up with a field training session that outlined the survey protocols and bat evidence to record *in situ* to volunteers (Plate 2).

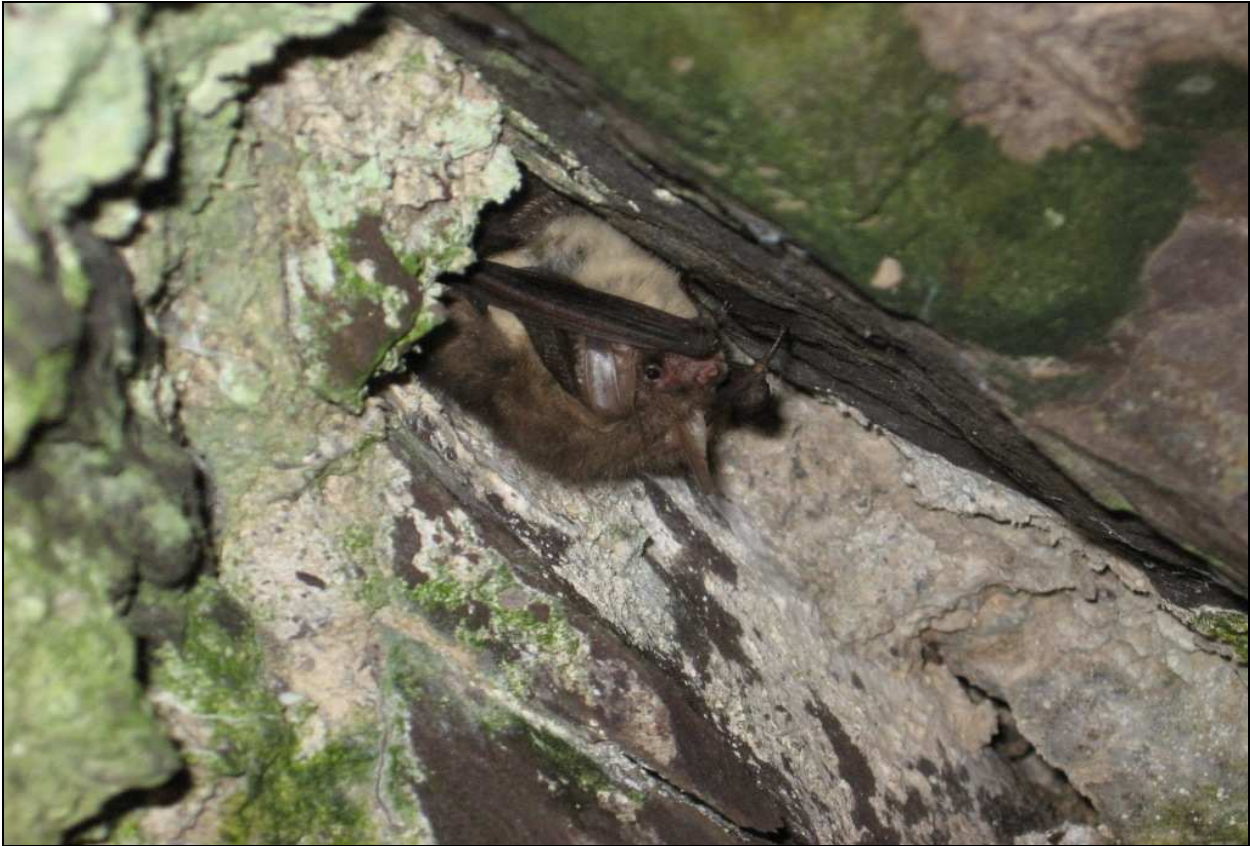
Plate 3: Brown long-eared bat using a crevice in a masonry bridge as a roost

Irish bat species that have been observed using bridges as roosts include Daubenton's, brown long-eared *Plecotus auritus* (Plate 3), Natterer's *M. nattereri*, whiskered *M. mystacinus* and common *Pipistrellus*

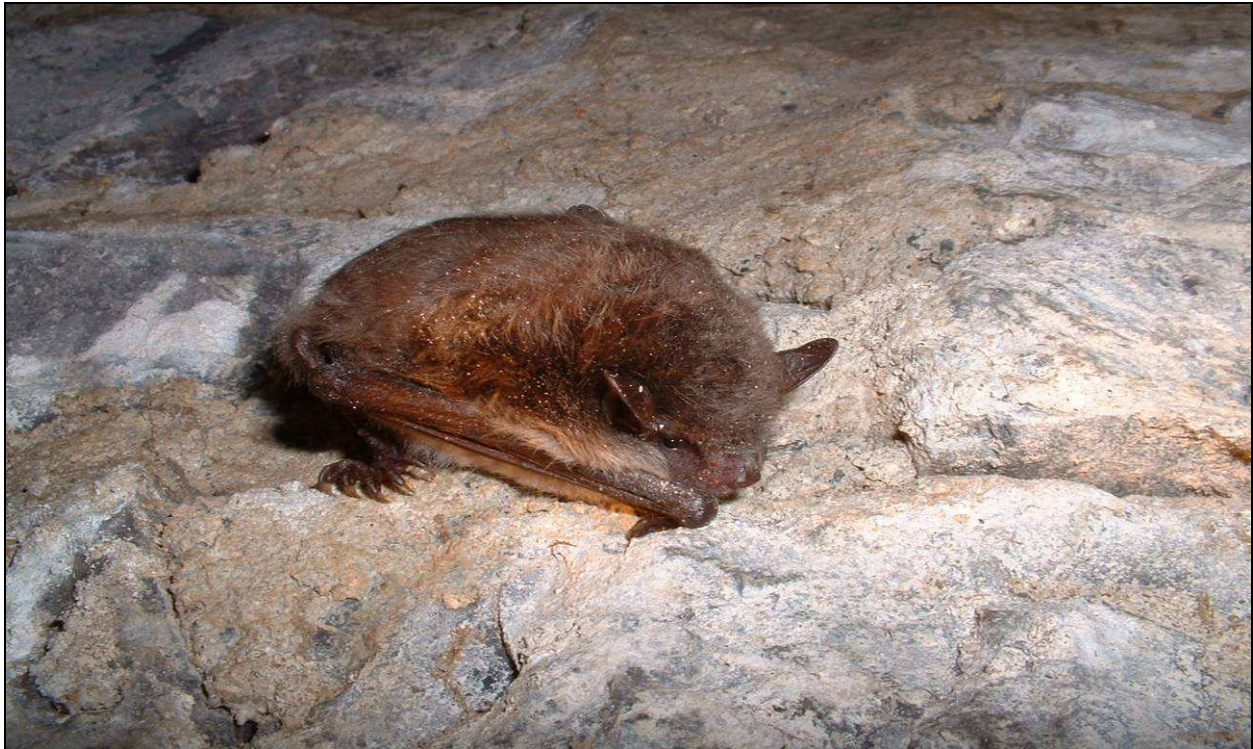
Plate 5: Daubenton's bat – the most common species found during the survey

Four bridges had evidence of bat usage; Bridge 102 was occupied by a single roosting Daubenton's bat (Plate 5), Bridge 084 had bat droppings present and Bridges 93 & 107 showed evidence of bat staining. All of these bridges are in the Laney River catchment.

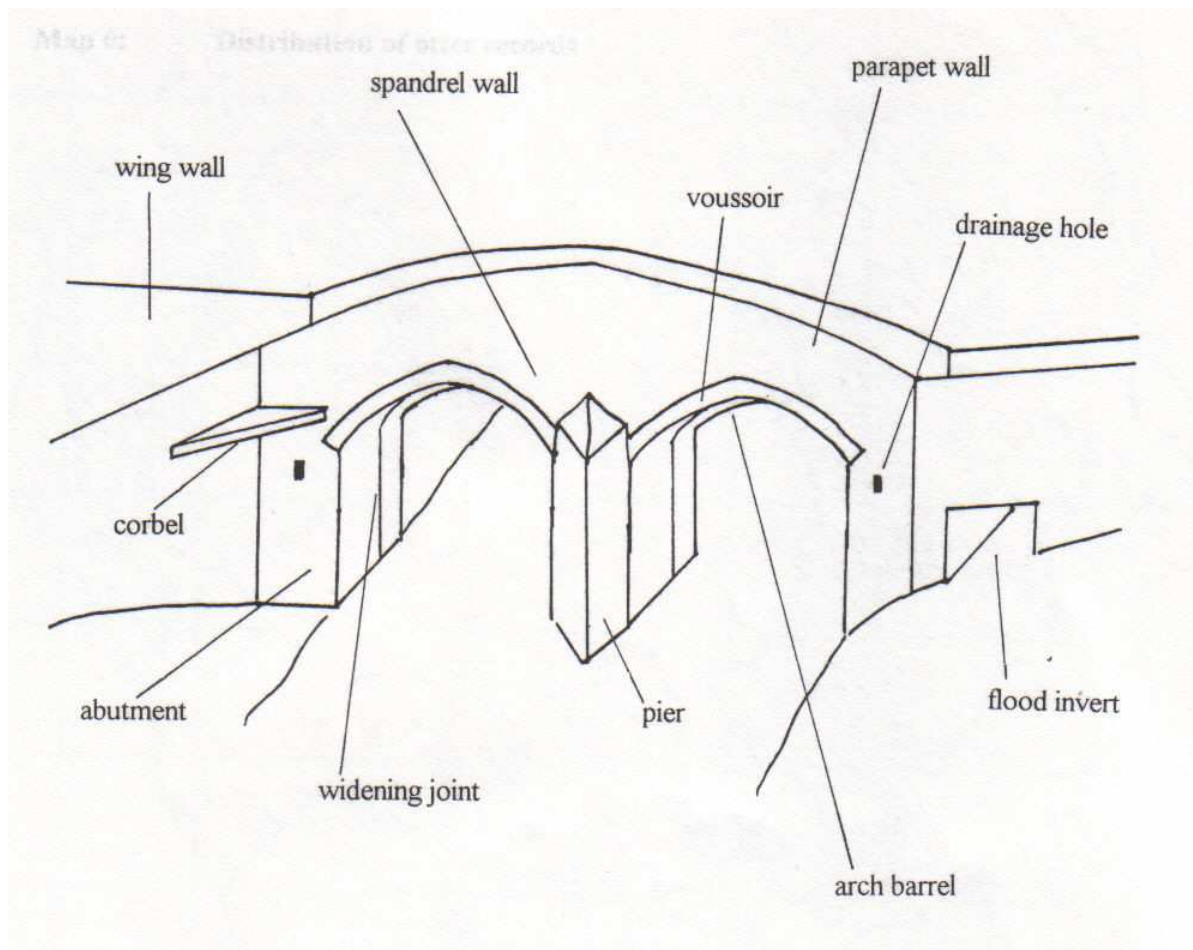
APPENDIX F: Bridge features terminology (From Billington and Norman 1997)

diagram of bridge architecture with labelled features for reference – reproduced in Appendix F, safety statement and field identification guides to bats and mammal tracks.
